Report No. GTL-DOT-11-VOLTBAT

# CHEVROLET VOLT BATTERY PACK TESTS

GENERAL TESTING LABORATORIES, INC.  
1623 LEEDSTOWN ROAD  
COLONIAL BEACH, VIRGINIA 22443

FINAL REPORT

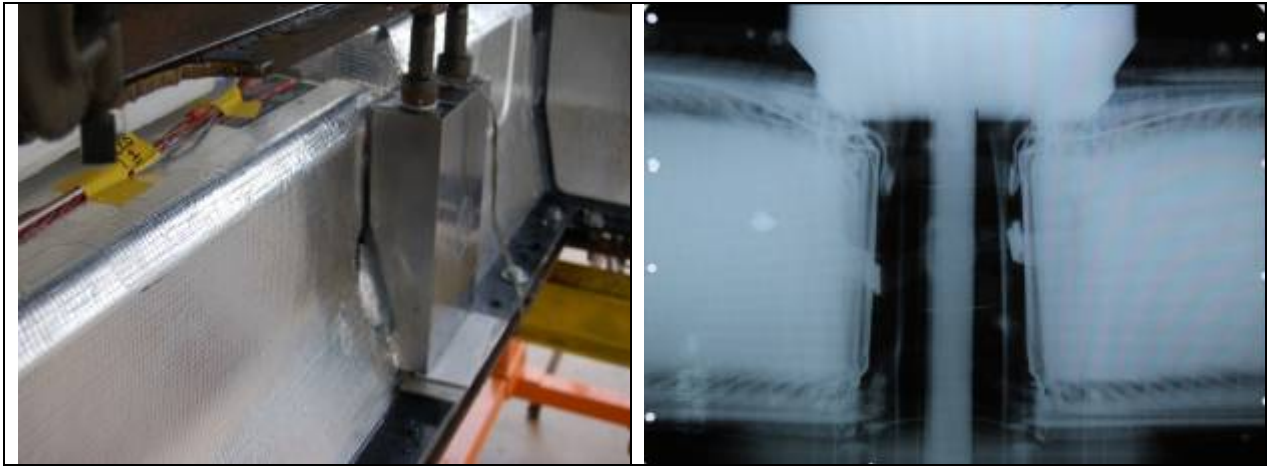
Figure 7.1 – Test 1 Battery Damage and X-Ray

There were only two minor differences between the two tests. During Test 1, the impactor block was not intentionally grounded to the mounting frame as was the case for Test 2. In addition, the degree of physical damage was slightly increased for Test 2 by adjusting the depth of impact and increasing the test impact velocity. A photograph and an X-ray of the damage for the two tests are provided in Figures 7.1 and 7.2.

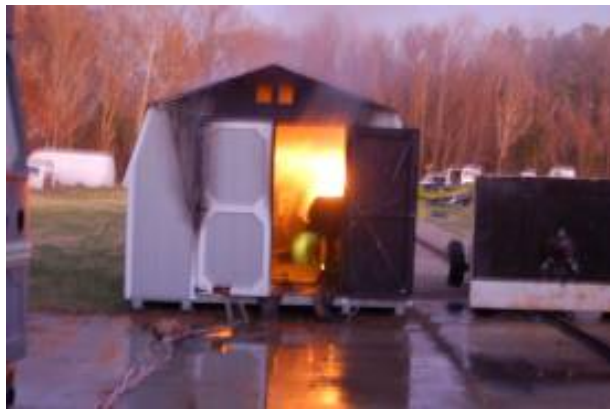
Figure 7.4 – Photograph Showing Early Stage of Fire

14. Interior of shed significantly charred when door blew open indicating that the fire had been burning for a while prior to the pressure event. Test 2 battery fully involved, Test 1 battery heating but not involved.

15. Only the Test 2 battery is involved at the time of the initial attack
16. Flames jetting from drivers side end of Module 3 and opening in cover observed at that location

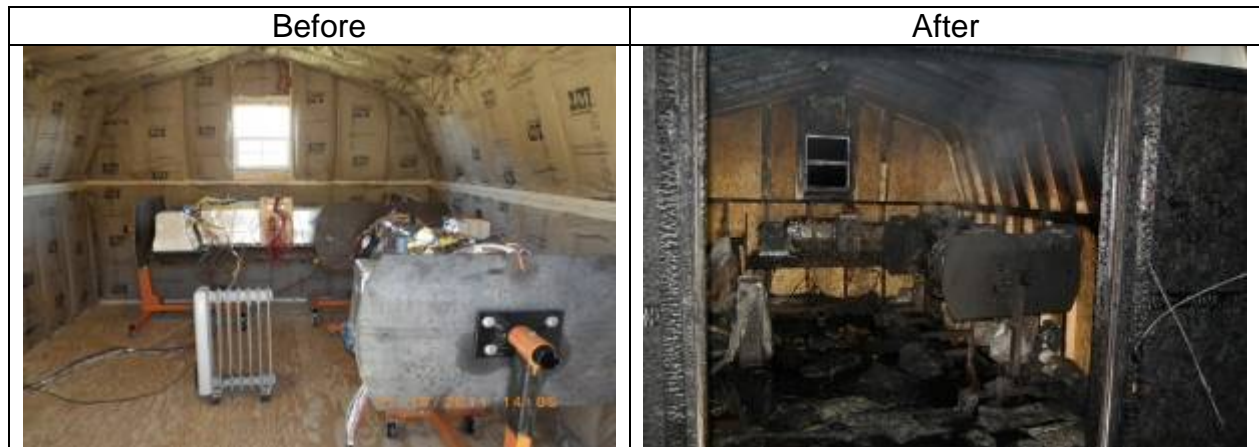
Figure 7.6 – Photograph Showing the Contents of the Shed Before and After the Event

The forensic investigation is consistent with the measurements, video footage and observation solicited from the fire fighters that combated the fire. The damage to the shed structure, based on visual observations and char depth, supports the fire originating in Battery from Test 2. The area above and adjacent to the open end of Battery from Test 2 experienced the greatest damage during the event.

The damage is consistent with the following scenario: The fire originated in the Battery in Test 2. The fire then spread to the paper facing on the insulation installed on the inner surfaces of the shed. As the paper facing was consumed, the oxygen concentration in the shed dropped causing the fire to become oxygen limited. The fire then smoldered for about 10 minutes prior to the overpressure that blew open the door.

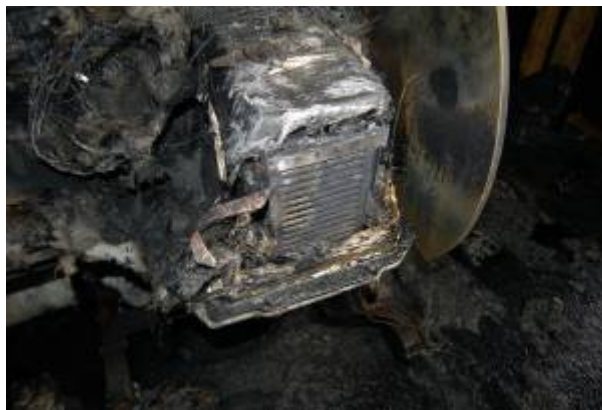
Figure 7.7 – Photograph Showing Cover Damage on the Driver's Side end of Module 3

There are two potential causes for the over-pressure event; a rapid influx of air into the shed and/or a single or multiple cell rupture in Section 3 of Battery from Test 2. The likelihood of a rapid influx of air is extremely low based on the conditions of the shed before and after the event. In short, there were no openings into the shed to allow a rapid influx of air. In addition, there was little if any wind the day of the fire.

A single or multiple cell level event (i.e. rapid venting of electrolyte) is the most likely scenario. This would also explain the opening in the case at the driver's side end - Module 3 of Battery from Test 2. A photograph of the opening is provided in Figure 7.7.

As stated previously, it is also believed that this cell venting blew apart the battery cover at the end of Module 3 during the fire and may have blown open the doors to the shed when the fire department first arrived on scene.

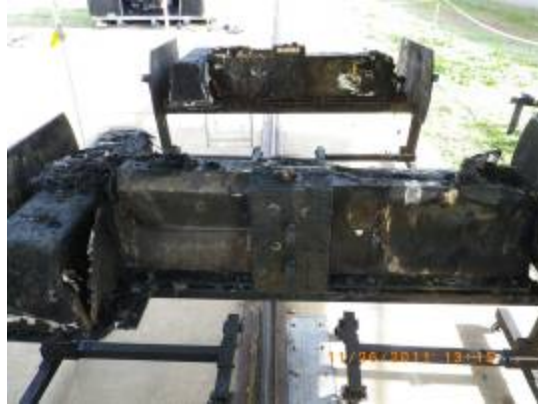
Figure 7.8 – Photograph of Batteries from Tests 1 and 2 (Battery from Test 2 is closest to the photographer)

As a general statement, a significant amount of the combustible materials in both batteries were consumed during the fire. A photograph showing two batteries is provided as Figure 7.8.

The forensic investigation of the battery from Test 2 placed the origin of the fire on the top of the module. However, the exact origin of the fire could not be determined. The electrical shorting caused by the coolant solution that was observed during the other tests conducted during this program suggest that the fire could have originated in any of the circuitry (i.e. VTSM cards and/or cable connections) located on the top of Module 3.

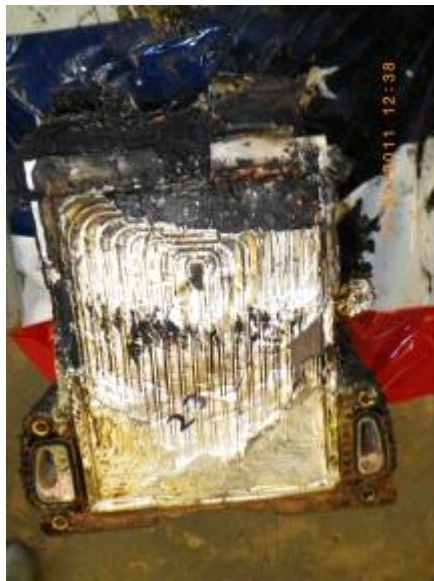
Figure 7.9 – Photograph Showing Cell Level Damage within Module 3

The battery forensic investigation also concluded that a number of cells vented during the fire, due to the elevated temperatures inside of the battery case adding to the severity of the fire. This conclusion was based on the damage observed to a limited number of cells throughout the module. Specifically, there were a number of cells where the copper current collector sheets had been melted and/or consumed just below the cell tabs. Since copper melts at approximately 1080°C, this could only occur if the electrolyte was venting out of the cell at this location. The aluminum current collector sheets and cooling fins were also destroyed at these locations (i.e. aluminum melts at approximately 660°C). A photograph of this damage is provided as Figure 7.9.

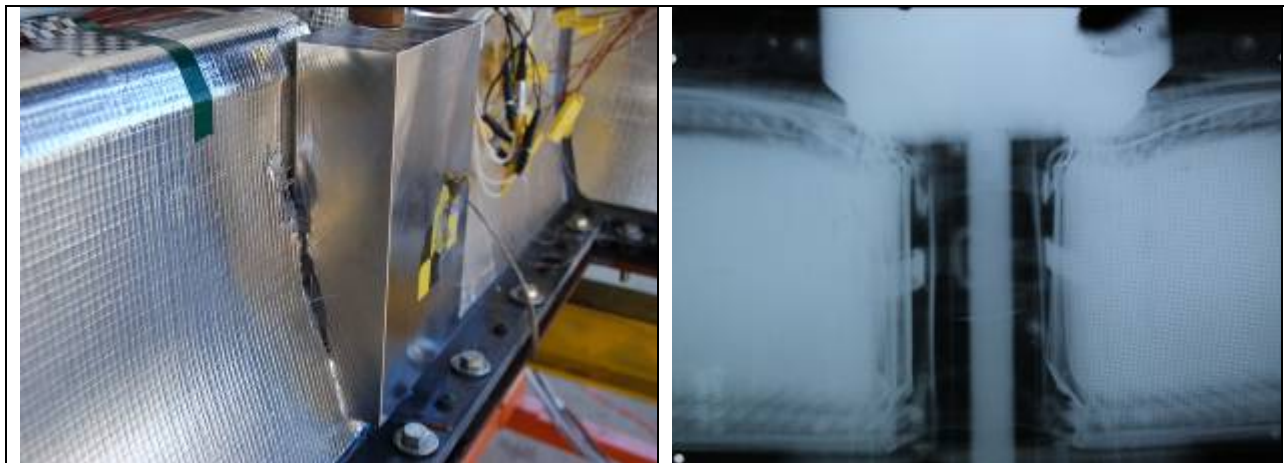
Figure 7.10 – Test 3 Battery Damage and X-Ray

The impact penetration was slightly increased for each test in an attempt to reproduce the damage to the battery produced during the crash test conducted in May at the MGA facility in Wisconsin. The amount of battery coolant (ethylene glycol/water mix 50/50) leaked into the pack was also greater than that leaked during the first two tests. A photograph and an X-ray of the damage for this test is provided in Figures 7.10.

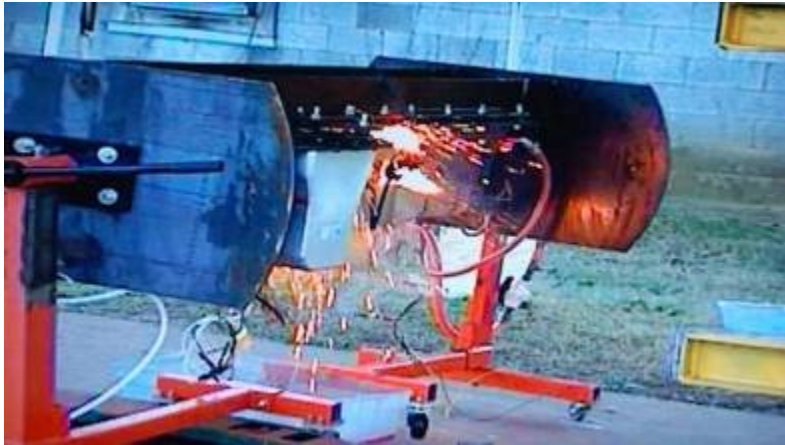
Figure 7.11 – Photograph Showing Flames and Sparks from Test 3 Battery

The event occurred during the rotation of the battery after the impact (about an hour after the impact). The battery was x-rayed after the impact. The battery pack was then tilted about 1 degree downward (the front end of the battery was 1 degree lower than the back end) to simulate the conditions during the rotation at MGA in May. The battery was then rotated at 90 degree increments (toward the passenger side) and held at that orientation for five minutes prior to continuing the rotation. The battery was upside-down at the time of the event. It was estimated that a majority of the coolant was located in the front section of the battery (Module 1) at the time of the event. A photograph of the event is provided as Figure 7.11.

4. About 5 minutes after the rotation to the 180 degree position, the battery housing began to fill with smoke as the temperatures continued to rise.
5. Smoke was observed leaking out of the pack at the impact location.

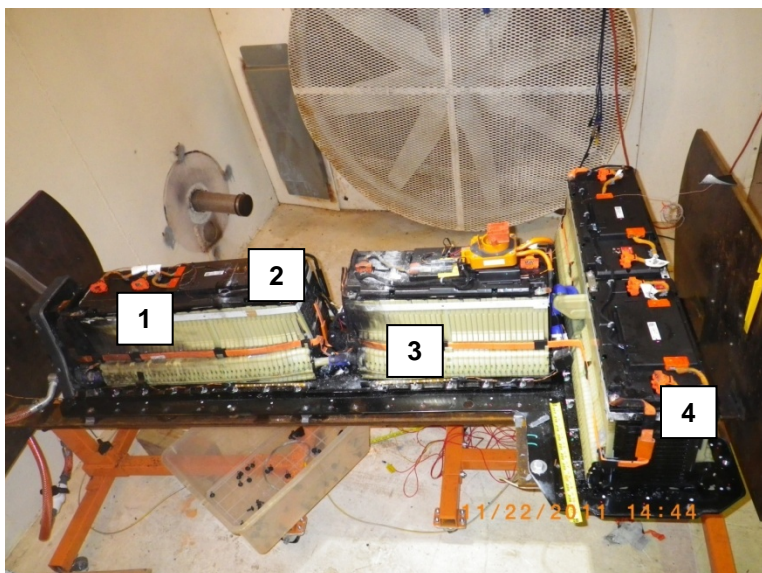
Figure 7.12 – Test 3 Arcing Locations

These locations are shown in Figure 7.12. and are discussed in the following paragraphs.

Generally speaking, the arcing was attributed to both the structural damage to the battery caused by the impact, and the shorting of various components due to the exposure to the electrically conductive coolant solution.

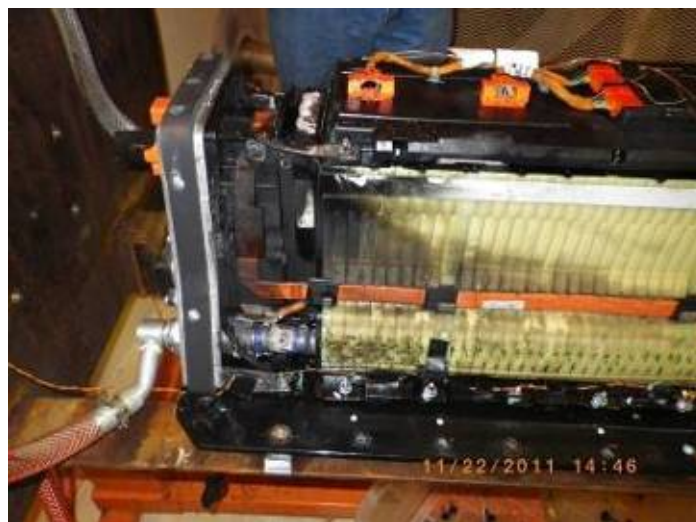
Figure 7.13 – Arcing Damage to the Front of Module 1

The front of Module 1 had arcing damage near the positive battery terminal and was stained with smoke and combustion products as shown in Figure 7.13. In addition, the front end plate of Module 1 had arced to the bottom support frame.

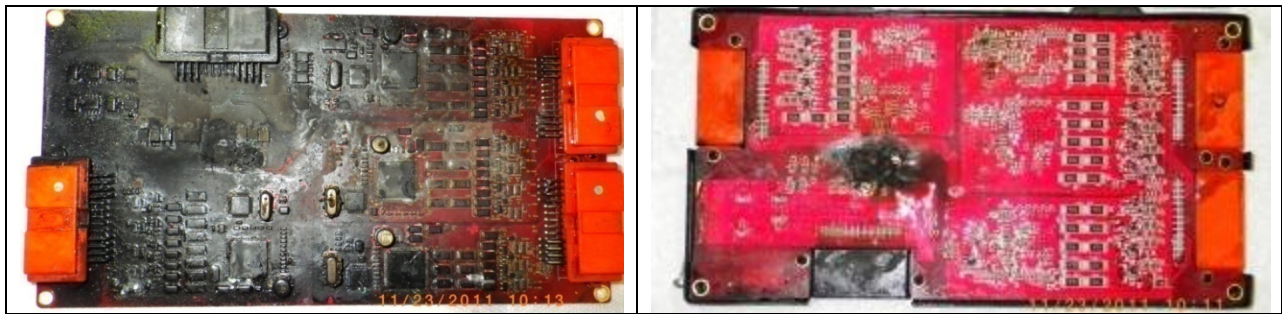
Figure 7.14 – Arcing and Heating Damage to VTSM 1

The plastic cover over VTSM1 had a small penny size area where the plastic had started to melt. Circuitry below the cover was visibly damaged and was warm to the touch and was still generating a small amount of heat at the time that the battery was disassembled. A photograph of VTSM 1 is provided as Figure 7.14.

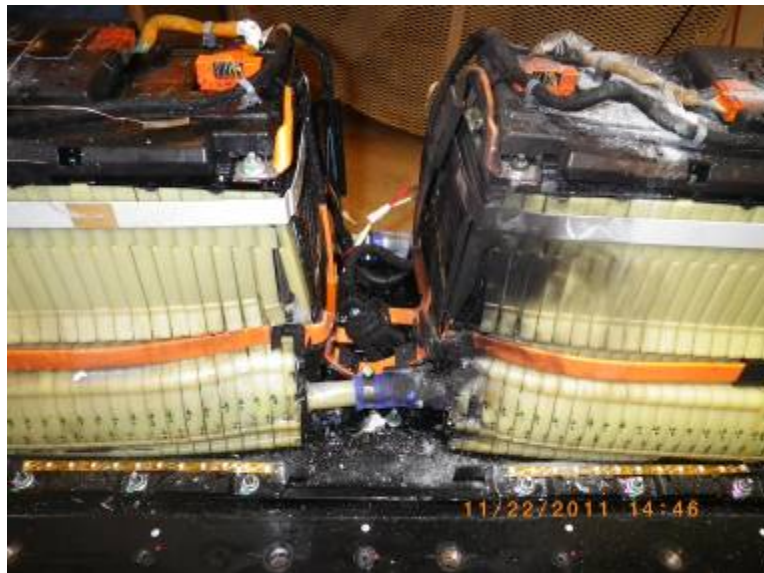
Figure 7.15 – Arcing Damage to the Front of Module 2

The greatest amount of electrical activity occurred at the front end of Module 2 as shown in Figure 7.15. As shown in the figure, most of the arcing occurred at the impact location. The negative bus bar that runs from Module 3 to the front of the battery was damaged by the impact and had arced to the front end plate of Module 2. The bottom of the end plate that supports the cooling line had arced to the impactor block and was completely destroyed in the process.

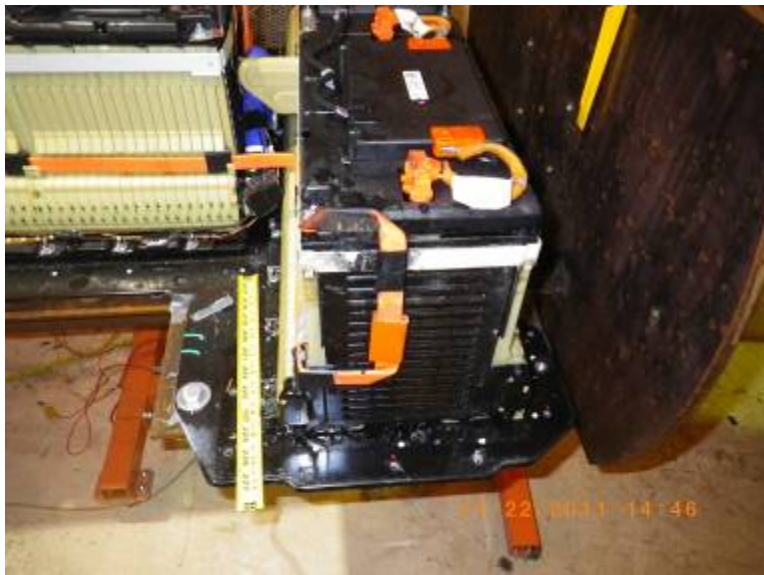
Figure 7.16 – Arcing Damage at the Driver’s Side End of Module 3

The final area of damage was in Module 3 at the negative terminal as shown in Figure 7.16. There was evidence of arcing between the cells and the terminal at this location. Specifically, there was an opening in the cover plate directly below the junction between the terminal and the negative bus bar where the activity occurred.

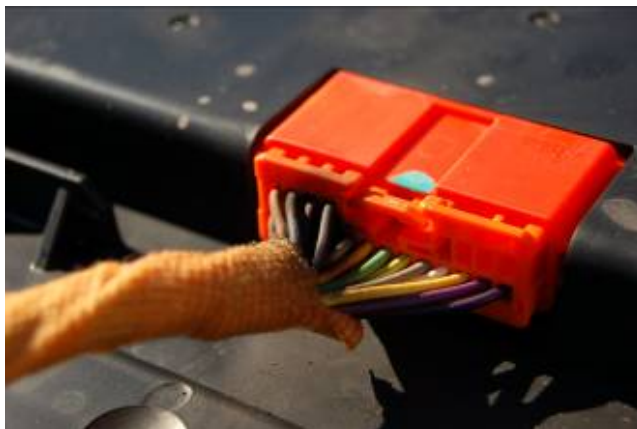
Figure 7.12 – Discoloration of wires and orange jacket

Post test visual inspection of the battery revealed discoloration(brown to black) on the wires and orange jacket leading from the orange connector on the battery to VSTM 3. See photograph at Figure 7.12.

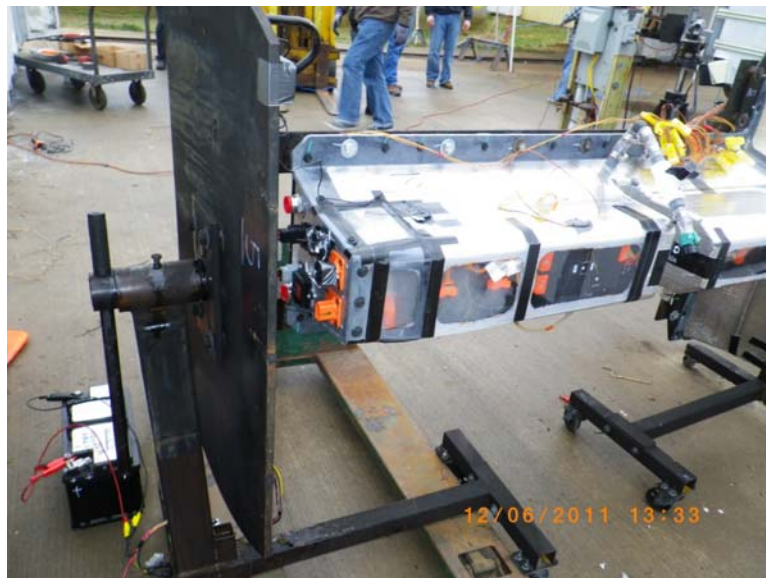
Figure 7.13 – Test 5 with the Battery at the 270 degree orientation

During the rollover portion of the test, between 180 degrees and 270 degrees, the coolant must have submersed the positive and negative terminals located on the driver's side of Module 1 causing rapid electrolysis of the coolant. A vigorous boiling sound could be heard as the battery was rotated through this orientation. The electrolysis abruptly stopped as the battery approached the 270 degree orientation and no other adverse effects were observed. A photograph showing the battery at the 270 degree mark is provided as Figure 7.13. Smoke can still be seen in the area where the shorting and electrolysis is believed to have occurred.

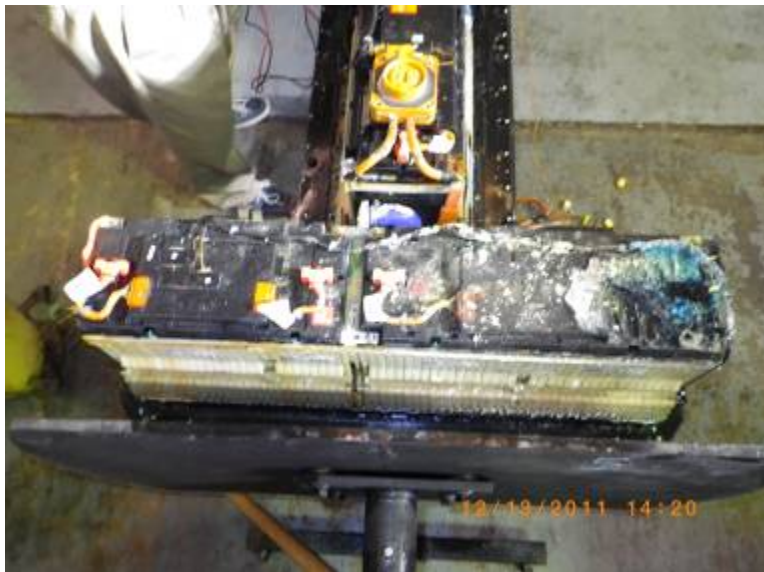
Figure 7.14 – Fire Damage to Passenger Side End of Module 3

Less than a week into the four week surveillance period, the Test 5 battery caught fire due to shorting of a connector on the passenger side end of battery Module 3. The location of the fire is shown in Figure 7.14. The fire was quickly suppressed by discharging water into the battery case. The battery was submersed by flowing water through the battery case until the test team returned to the facility, approximately 18 hours later.

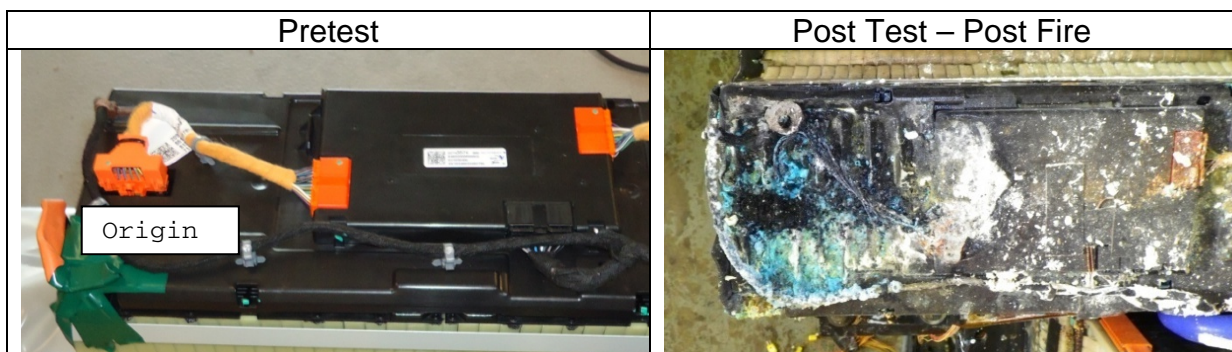
Figure 7.15 – Fire Origin of Test 5 – Passenger Side End of Module 3

Due to the rapid suppression of the fire, the exact origin of the fire could be determined. The forensic investigation of the battery revealed that the fire originated at the passenger side end of Module 3. Specifically, the fire originated at/in the connector on the battery between the voltage monitoring system bus bar and the cable for VTSM 3 as shown in Figure 7.15.

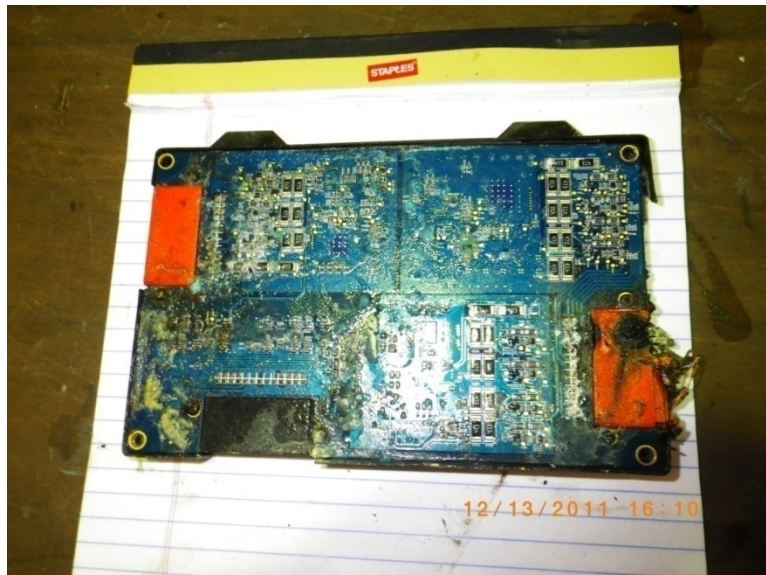
Figure 7.16 – VTSM 3 – No Apparent Fire Damage

The forensic inspection of the cells was consistent with the fire originating at the connection between the voltage monitoring system bus bar and the cable for VTSM 3. Specifically, there was no damage to any of the cells other than directly under the connector and there was no damage to VTSM 3. A photograph of VTSM 3 is provided as Figure 7.16.

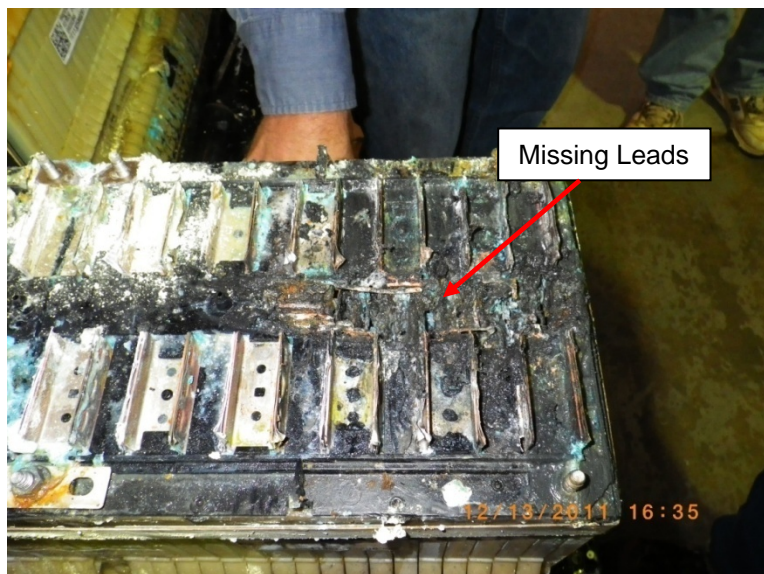
Figure 7.17 – Fire Damage to the Bus Bar Leads

The voltage temperature monitoring system leads that run through the bus bar were destroyed between the connector location and the passenger's side end of Module 3. These leads are fairly low gauge copper wires. Since copper melts at approximately 1080°C, this could only occur under high current flow conditions or if the electrolyte was vented out of the cell(s) directly below the leads. A photograph of these leads is provided as Figure 7.17.

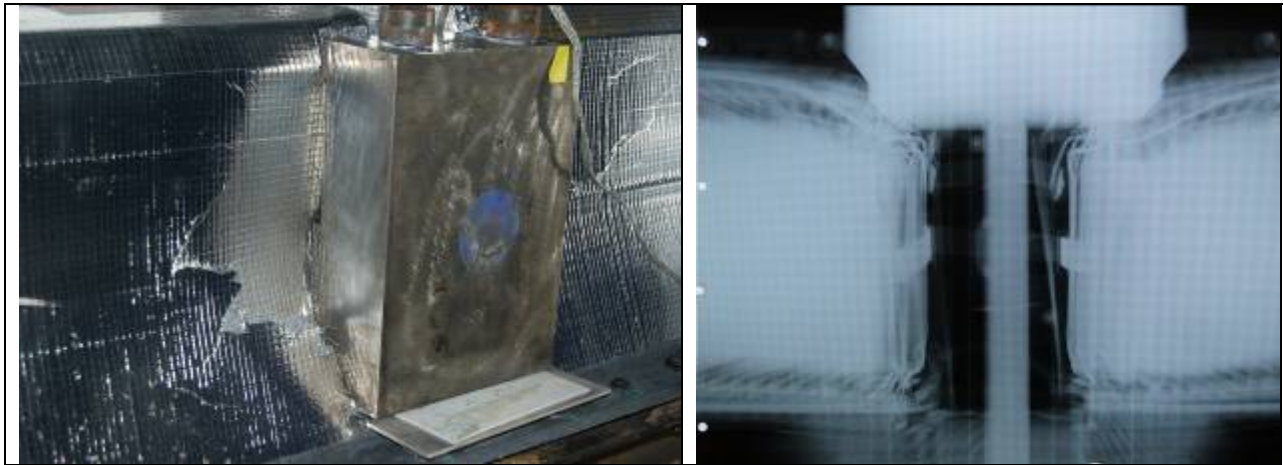
Figure 7.18 – Test 6 Battery Damage and X-Ray

One of the cell groups on the end of Module 1 located in the impact area slowly lost charge during the monitoring period. Voltage at the end of the monitoring period had dropped to 0.21 volts. A photograph and an X-ray of the damage for the test is provided in Figure 7.18.
