Report No. GTL-DOT-11-VOLTBAT

# CHEVROLET VOLT BATTERY PACK TESTS

GENERAL TESTING LABORATORIES, INC.  
1623 LEEDSTOWN ROAD  
COLONIAL BEACH, VIRGINIA 22443

FINAL REPORT

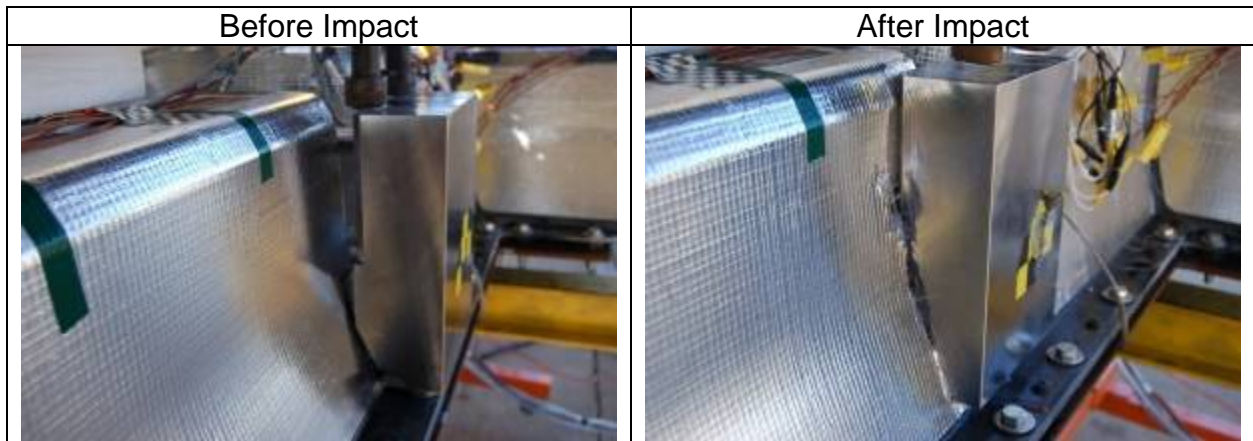
Figure 4.3 Sample Impactor Block Penetration

The impactor block was shaped to simulate the side of the tunnel and stiffener that penetrated the battery during the test at MGA. The impactor block was made of HY100 steel plate. The block was installed on the driver's side of the battery at the junction between Modules 1 and 2. Two 1" diameter rods were connected to the impactor block, run through the opening between the two modules and through a wood block assembly on the opposite side of the battery. Crimp rings were installed on the rods in the center of the wooden block to keep the device in compression after impact. A photograph of the impactor block assembly is shown in Figure 4.2. Photographs of the impactor block in position both before and after impact are shown in Figure 4.3.

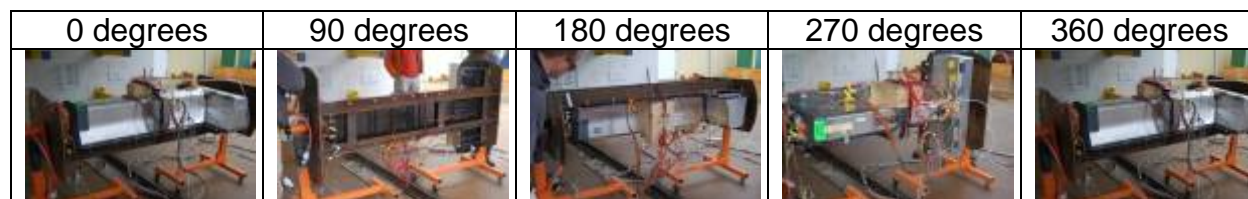
Figure 5.2 Battery Rollover Photographs

For tests that included rollover, the battery was rotated around the longitudinal axis 360 degrees at 90 degree increments as shown in Figure 5.2. The battery was rotated toward the passenger side of the vehicle. Once the battery was rotated each 90 degree increment, the battery was held in that position for five minutes prior to rotating to the next position. This is representative of the post crash procedures used by MGA on the Chevrolet Volt during the test in May 2011.

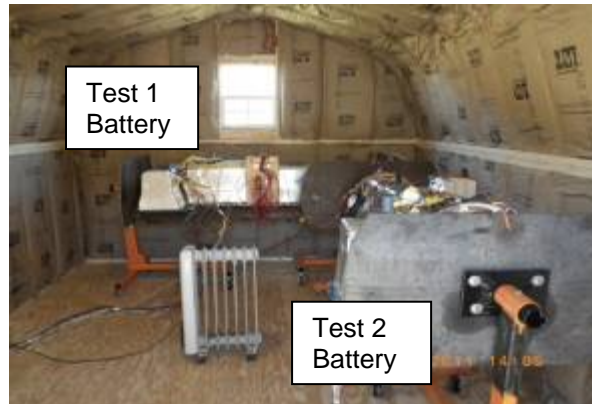
Figure 7.3 – Storage Configuration for Batteries from Tests 1 and 2

The orientation of the two batteries within the shed is shown in Figure 7.3.

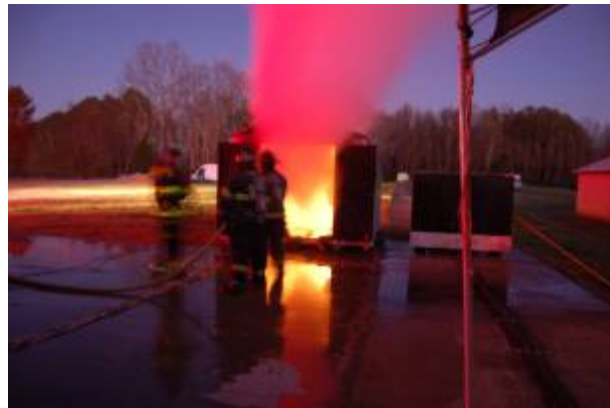
Figure 7.5 – Photograph Showing Final Attack on Fire

15. Only the Test 2 battery is involved at the time of the initial attack
16. Flames jetting from drivers side end of Module 3 and opening in cover observed at that location
